NHDOT Research Project 26962P
Reducing Cracks in New Bridge Curbs

Review of Cracking in Existing Bridge Curbs

September 14, 2017

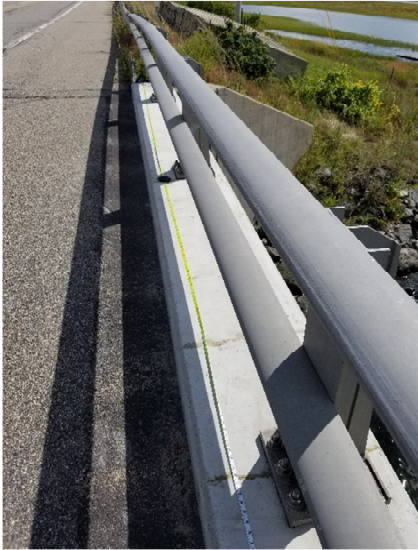
Figure 1: Tape measure on bridge curb

Upon arriving to the site, broad observations were made and documented using video recording. The recording included information on traffic, bridge surroundings, superstructure material, or any other noteworthy observations. Following initial observations, a tape measure was pulled from one end of the curb to the other (Figure 1). Locations of guardrail post centers from the end of the curb were recorded. Total curb length was also noted.

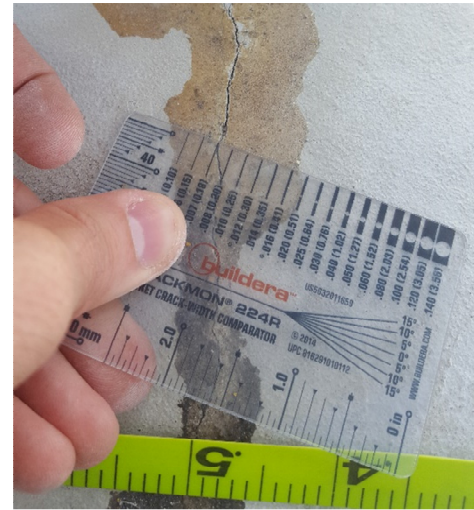
Figure 2: Crack comparator used to size cracks

Photos were taken at each crack along the curb with the tape measure in view as well as a crack comparator (Figure 2). When cracks were hairline in width the crack comparator was excluded from the photo. In order to capture the details of some cracks multiple photos were taken.
